Date of service: 10/04/25

Provider: Leon Tsigros (mechanic SAFE TO TOW)

Caravan Wheel Alignment Report

Caravan Wheel Alignment

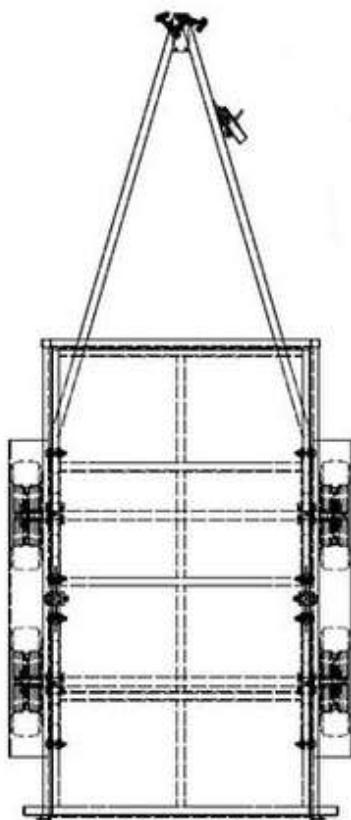
TOE IN/OUT

Before	After
-7mm	-0.5mm

Before	After
-1mm	0mm

Before	After
-2mm	0mm

Before	After
0mm	0mm

The customer presented with significant sway issues on their new (MAKE/MODEL) caravan. A comprehensive scope of service was undertaken, beginning with a detailed car and caravan weigh and compliance check, followed by a wheel alignment. The weight distribution analysis revealed an underweight tow ball and excessive weight at the rear of the caravan. To rectify this imbalance, the spare wheel was relocated to the front right-hand side storage compartment. This adjustment brought the weight distribution within safe limits — please refer to the attached weigh report for all relevant figures. Following the weight correction, a wheel alignment was conducted, with adjustments made in accordance with Cruisemaster alignment specifications — refer to the before-and-after report for full details.

The customer completed a test drive post-service and confirmed that the sway issue has been resolved. The caravan now handles safely and as expected.

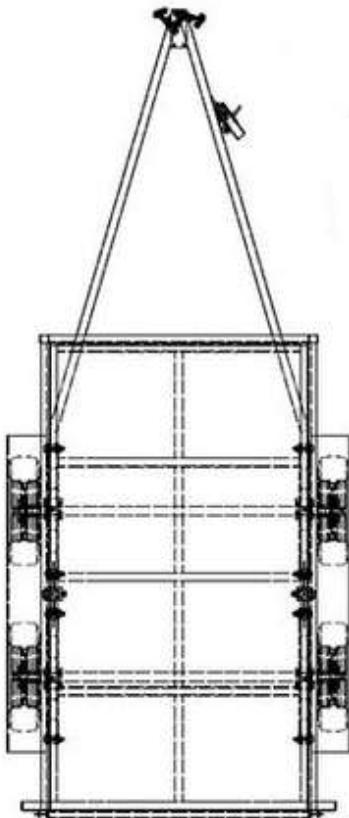
CAMBER

Before	After
-1.70°	-0.10°

Before	After
-0.35°	0°

Before	After
-1.05°	0.10°

Before	After
-0.40°	-0.10°
